NBS BUILDING SCIENCE SERIES 143

Investigation of the Kansas City Hyatt Regency Walkways Collapse

DEPARTMENT OF COMMERCE • NATIONAL BUREAU OF STANDARDS

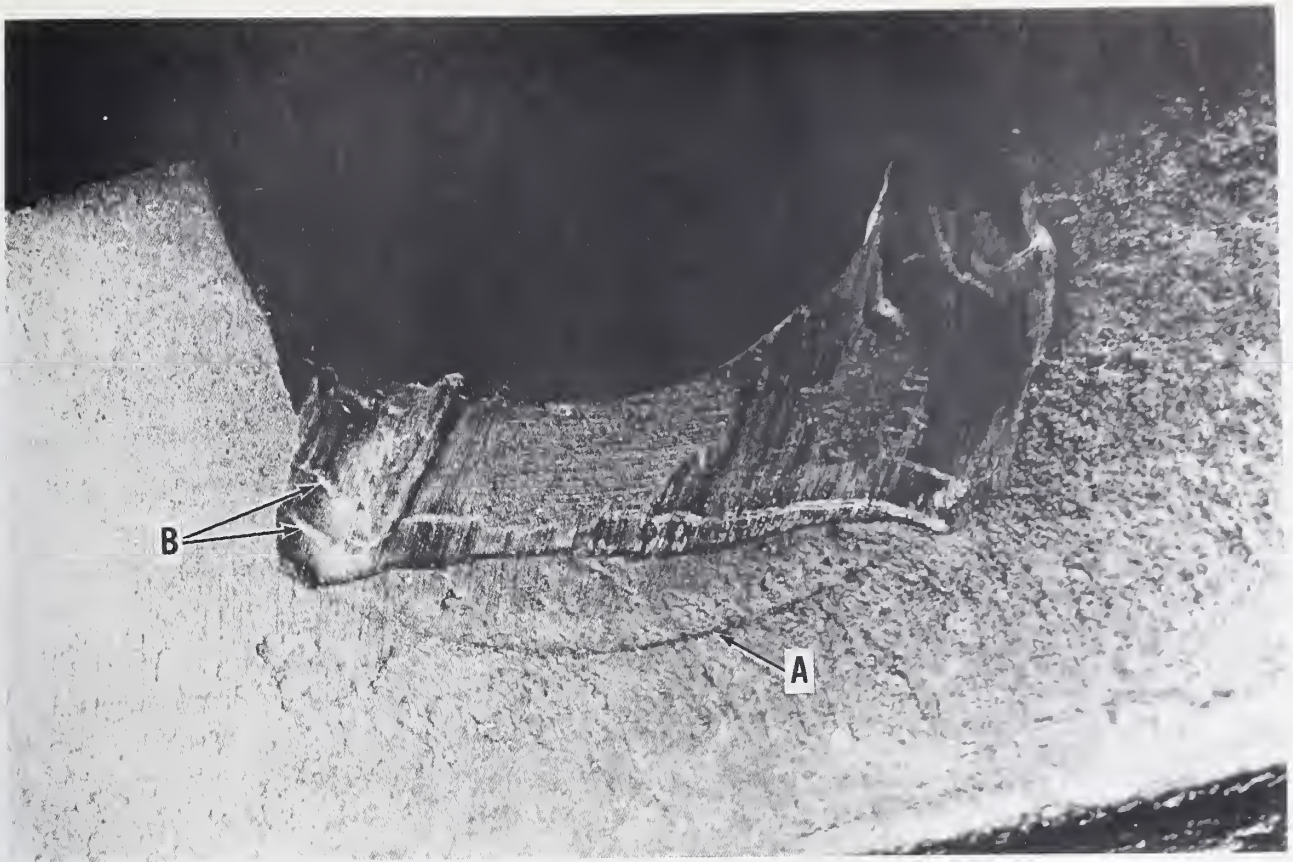
Figure 5.10 Deformation at underside, outer hole, location 9UE due to pull-through of washer/nut assembly. Note imprint of washer (A) and evidence of slip-stick progressive failure (B).

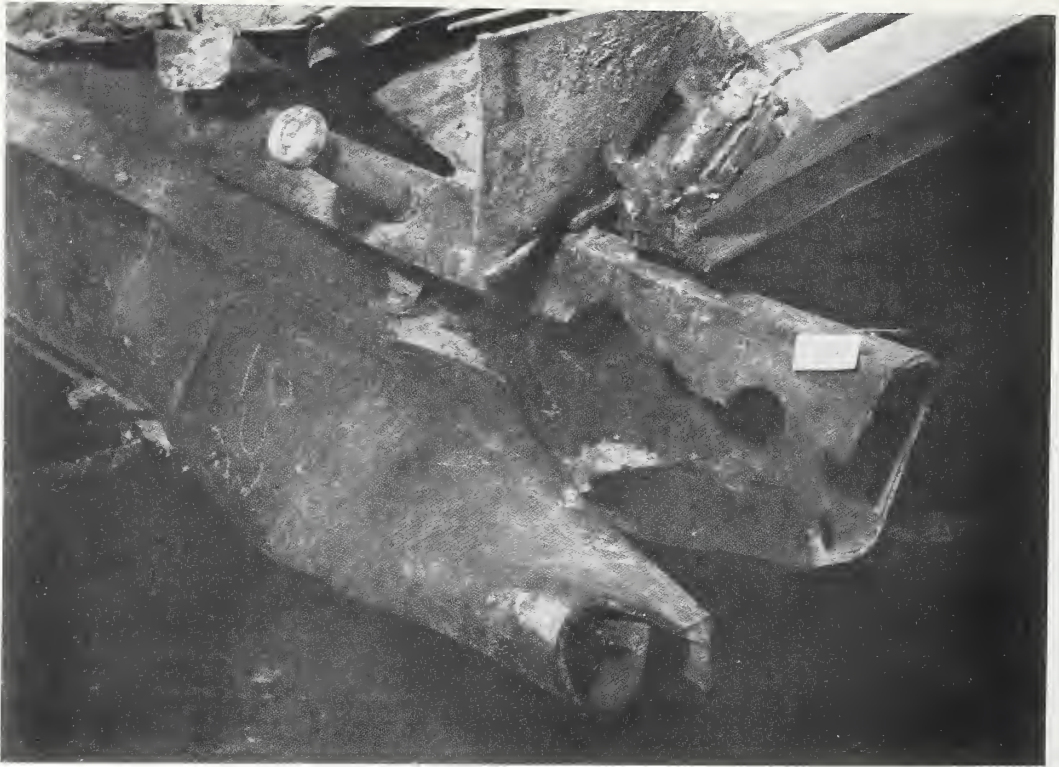
Figure 5.11 Box beam at location 10UW (Span U9-10).

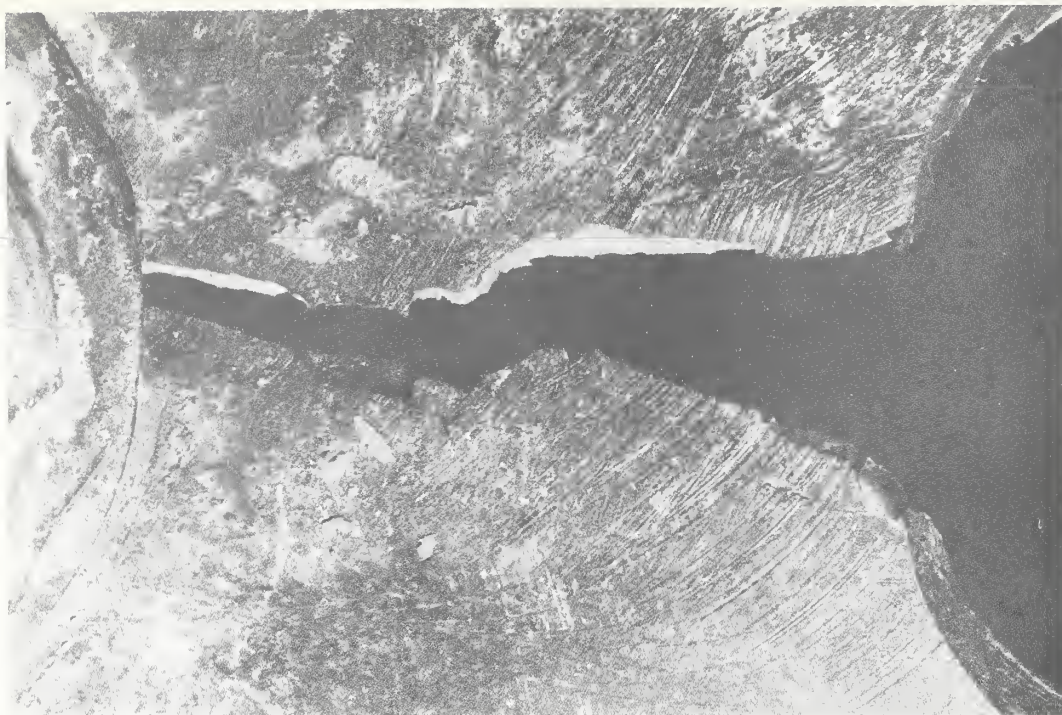
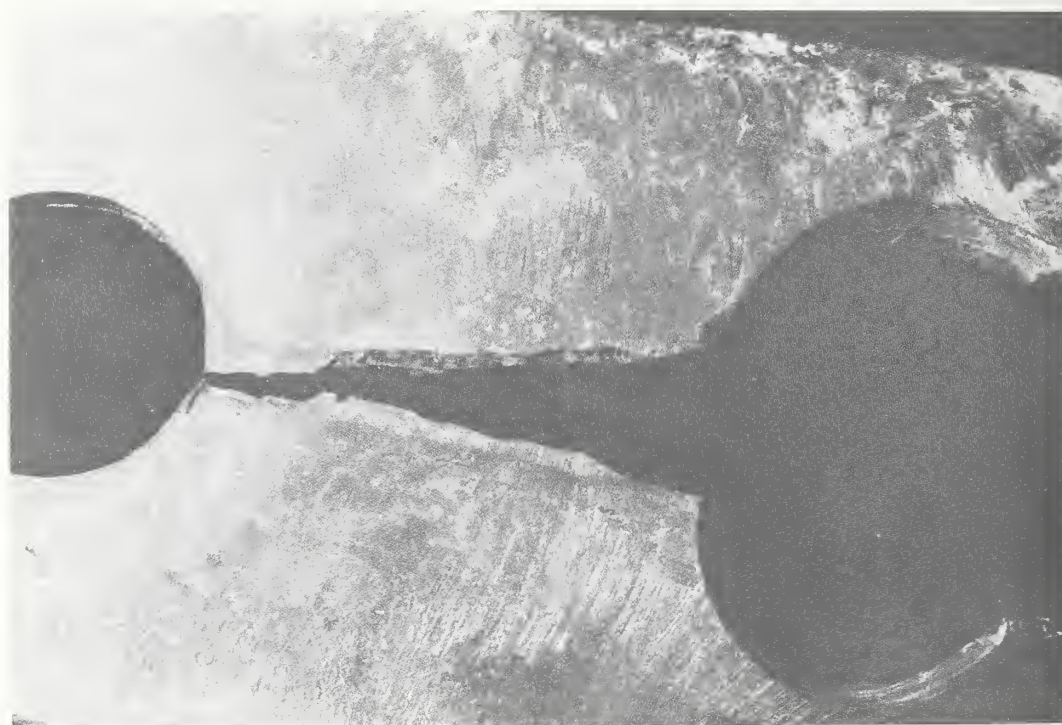
Figure 5.17 Fusion line weld fractures between hanger rod holes, upper flange weld, locations 9UE(a) and 8UE(b).

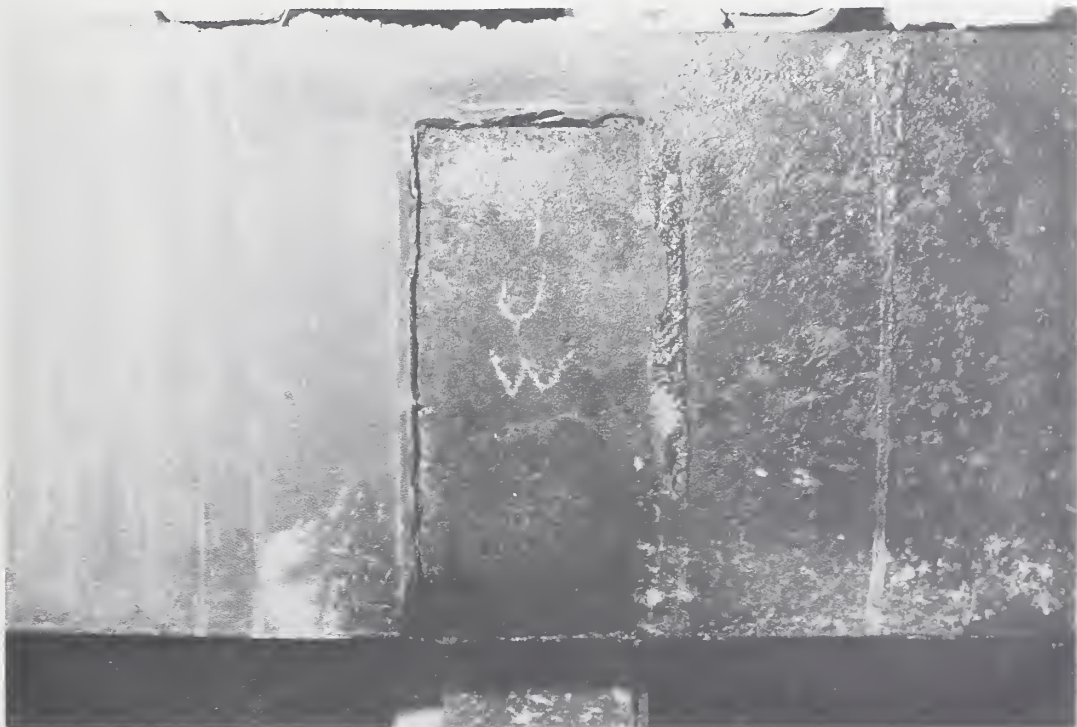
Figure 5.22 Shear failure in clip angle fillet weld at location 9UW, north side. This weld and the corresponding weld at location 9LW did not show evidence of a pull-out (tensile) failure at the top fillet weld.

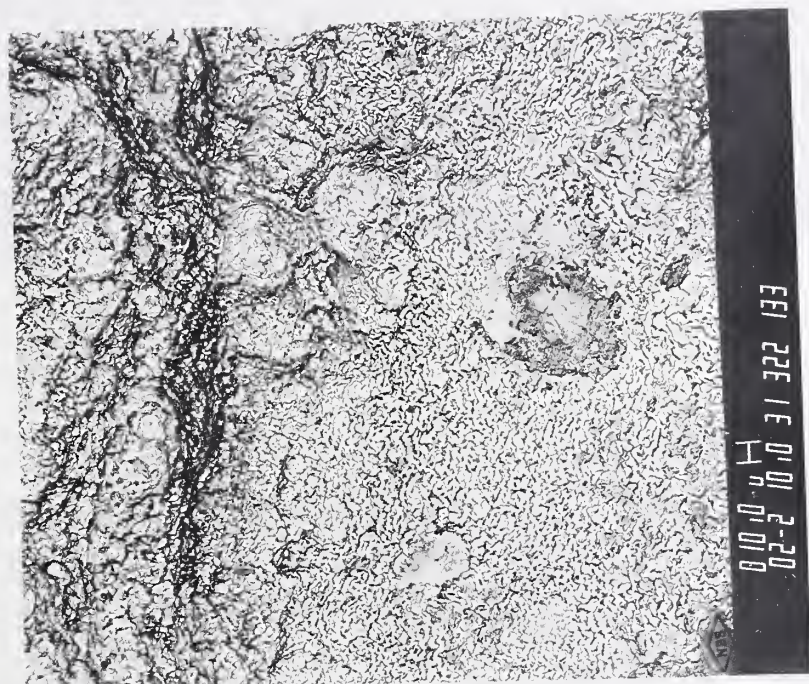
Figure 8.4 Photomicrograph of a replica from the shear lip region at location 8UE.
The surface oxidation has removed the fine shear dimpled rupture features
in this area. Magnification X250.

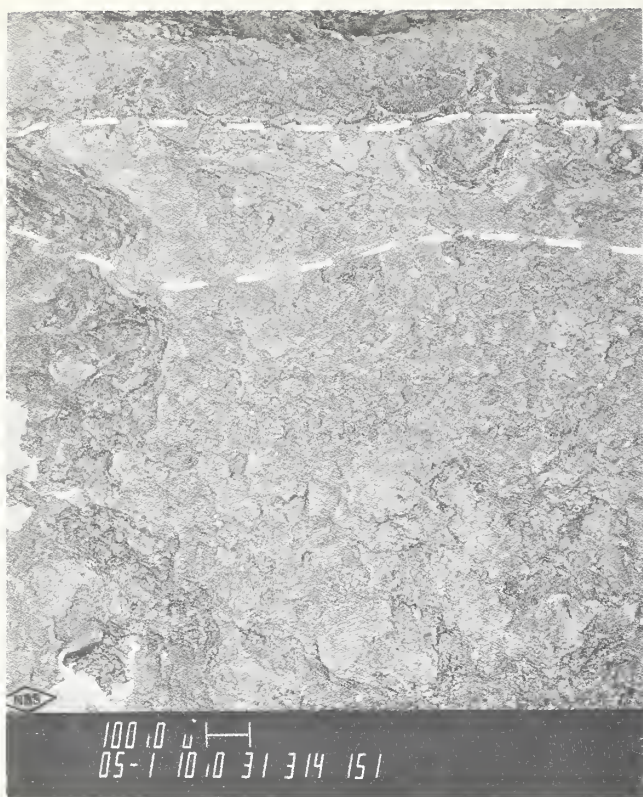
Figure 8.5 Fractographic evidence of pre-existing cracks in walkway box beam exterior longitudinal welds at locations (a) 9UW, (b) 9UE, (c) 8UW. Regions interpreted as cracks outlined by dashed lines. Magnifications X55, X250, and X25, respectively.

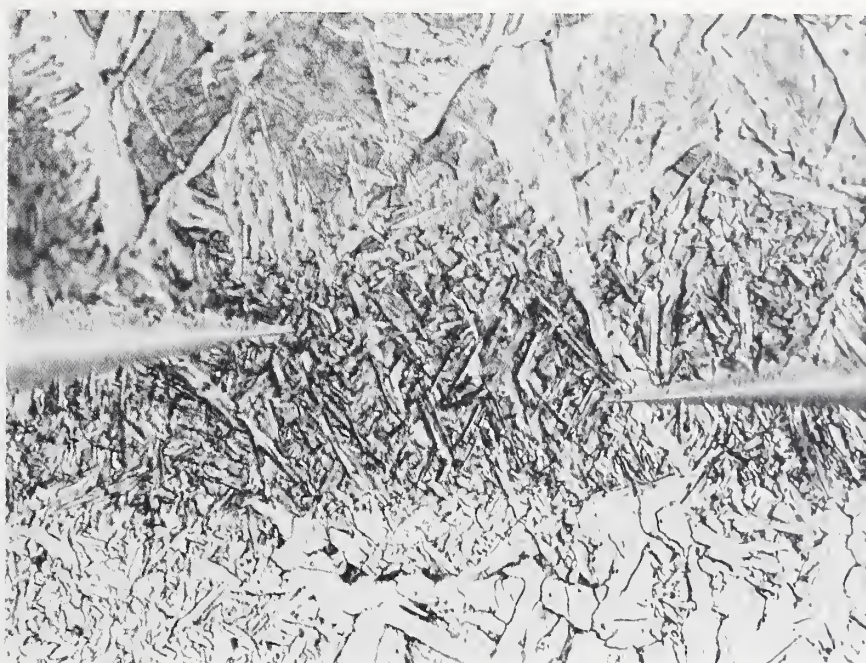
Figure A7.4.1-15 Hard area similar to that shown above, but at higher magnification. The hard area is in the center running from side to side. The microstructure appears to consist of fine grained tempered martensite. Parts of two hardness impressions can be seen at either side of the figure. Etchant: two percent nital. X800
